Land Subsidence Rate in the Northeast Phoenix and Scottsdale Areas, Maricopa County
Based on Radarsat-2 Satellite Interferometric Synthetic Aperture Radar (InSAR) Data

Time Period of Analysis: 2.0 Years 04/17/2014 To 04/06/2016

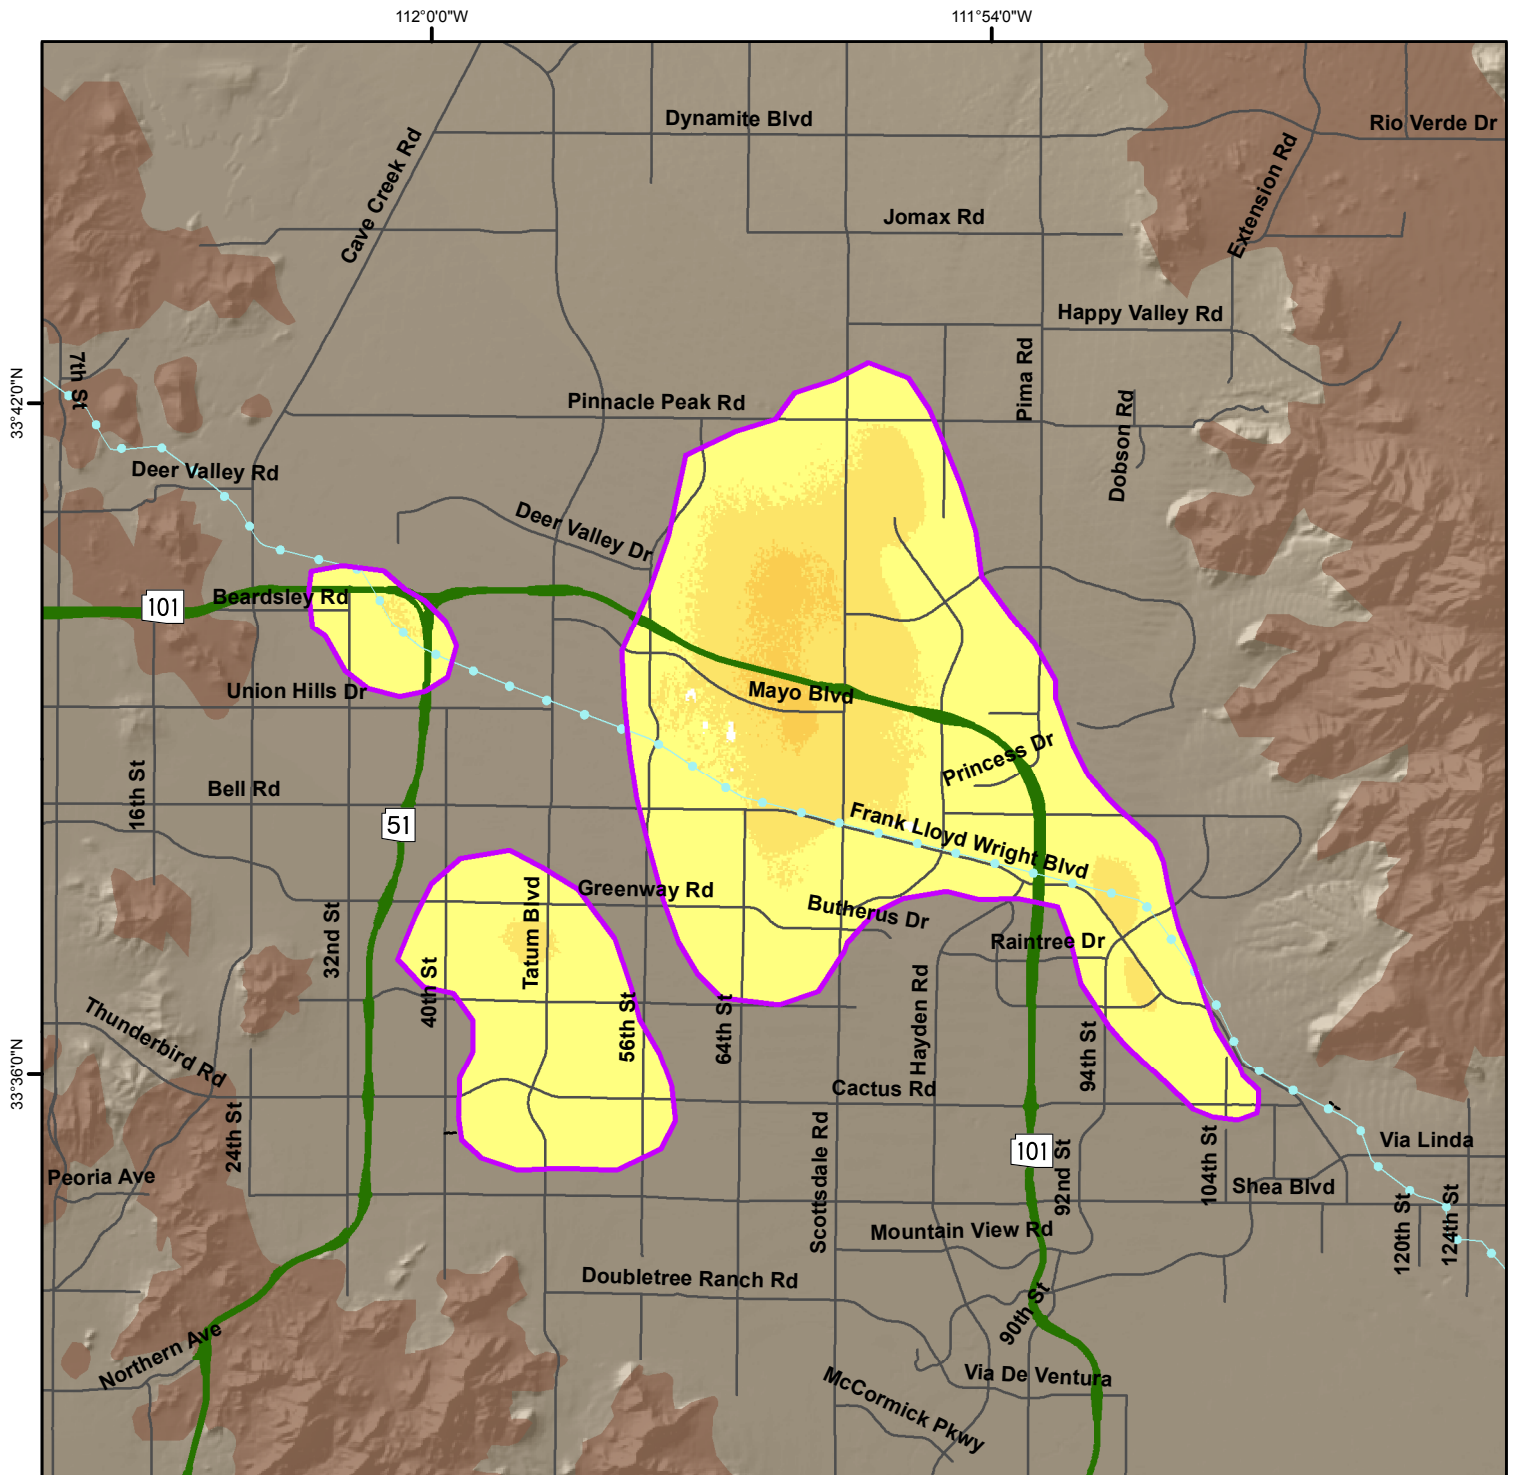
Decorrelation (white areas) are areas where the phase of the received satellite signal changed between satellite passes, causing the data to be unusable. This occurs in areas where the land surface has been disturbed (i.e. bodies of water, snow, agriculture areas, areas of development, etc).
